THE GREAT ALASKA EARTHQUAKE

Volume II

Illustrations and Maps

TECHNICAL REPORT NO. AFWL-TR-65-92, Vol II

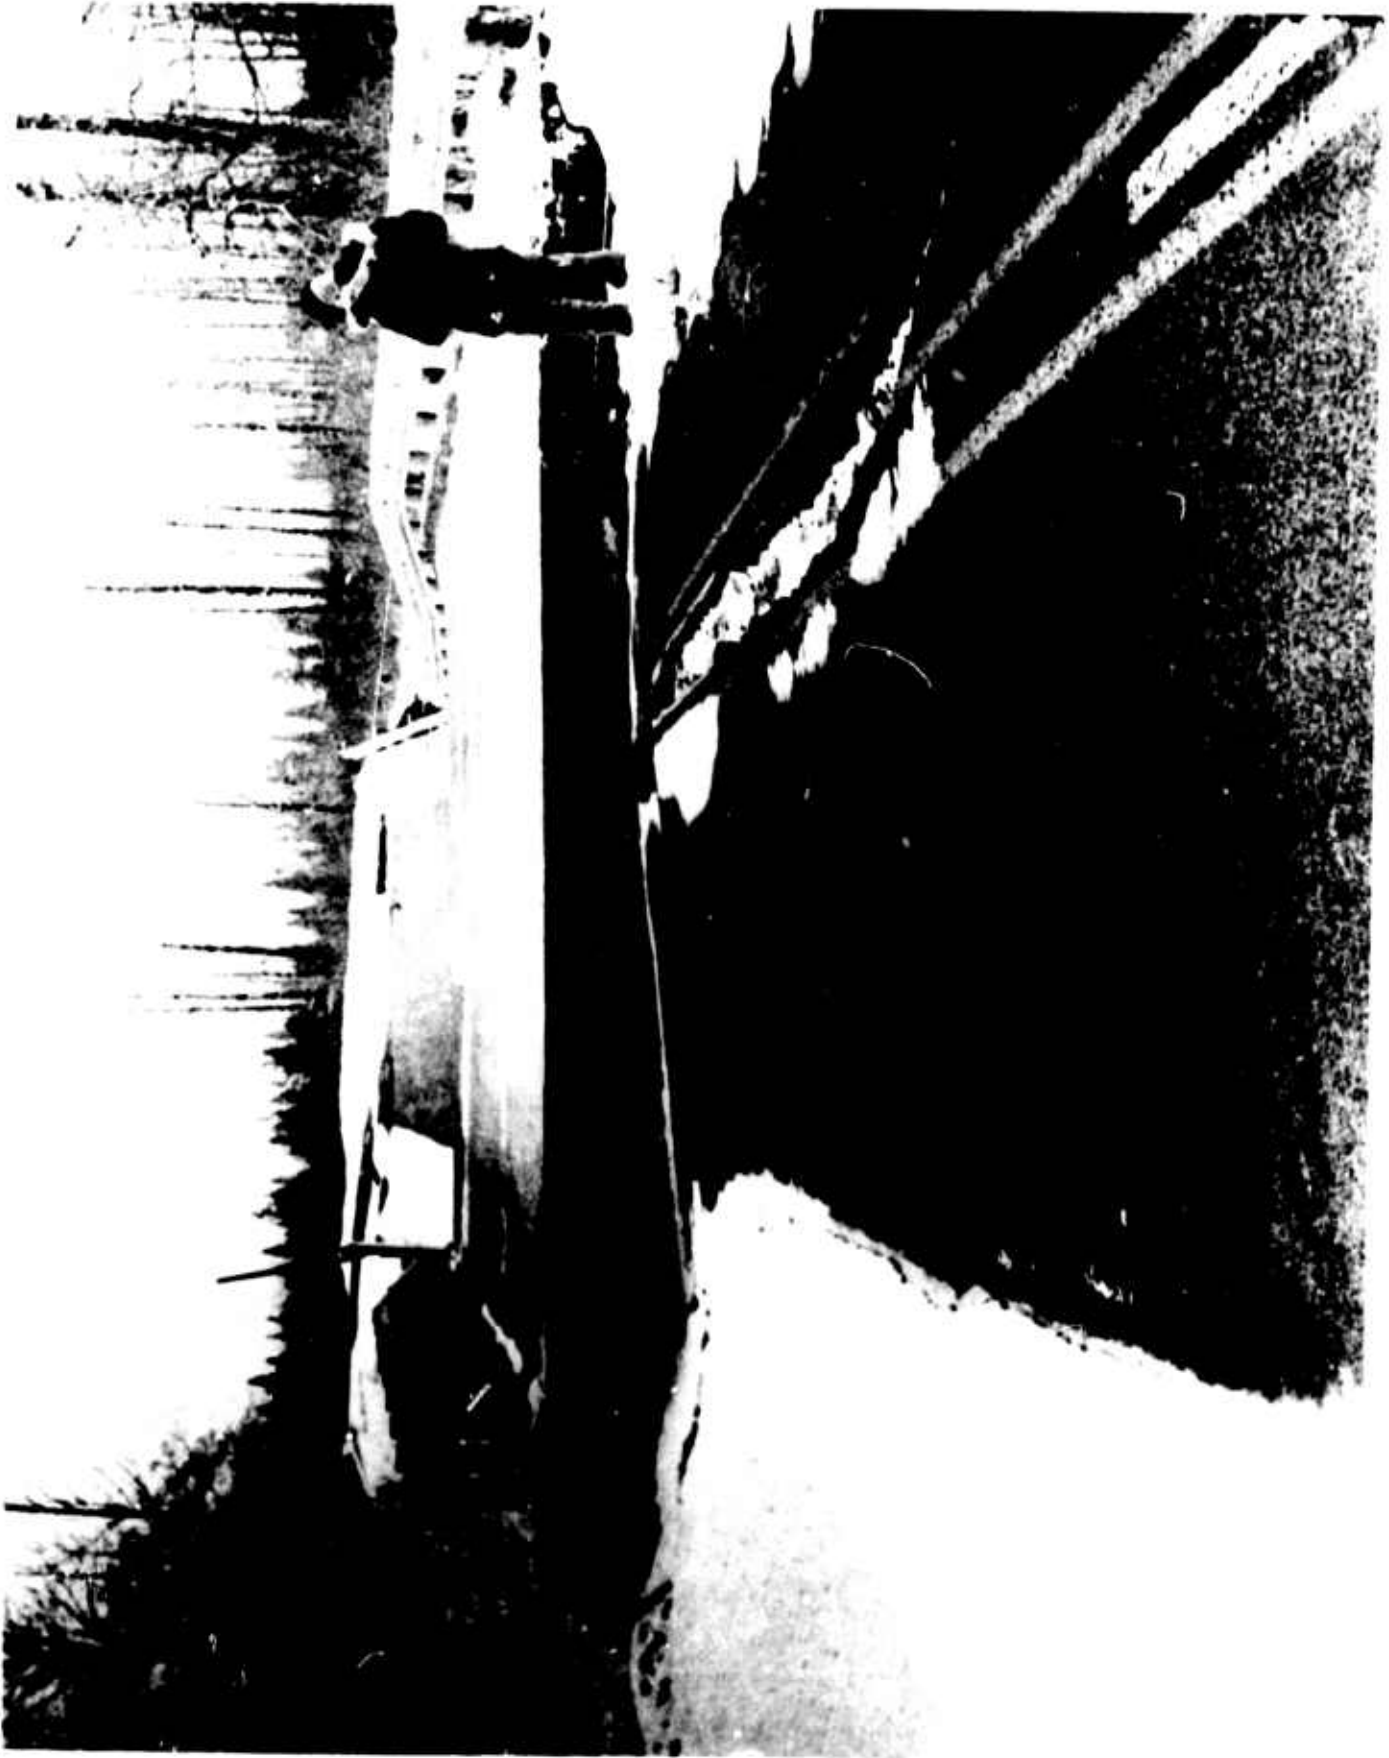
Figure 20. Roadbed Subsidence Adjacent to a Bridge, Anchorage to Seward Highway

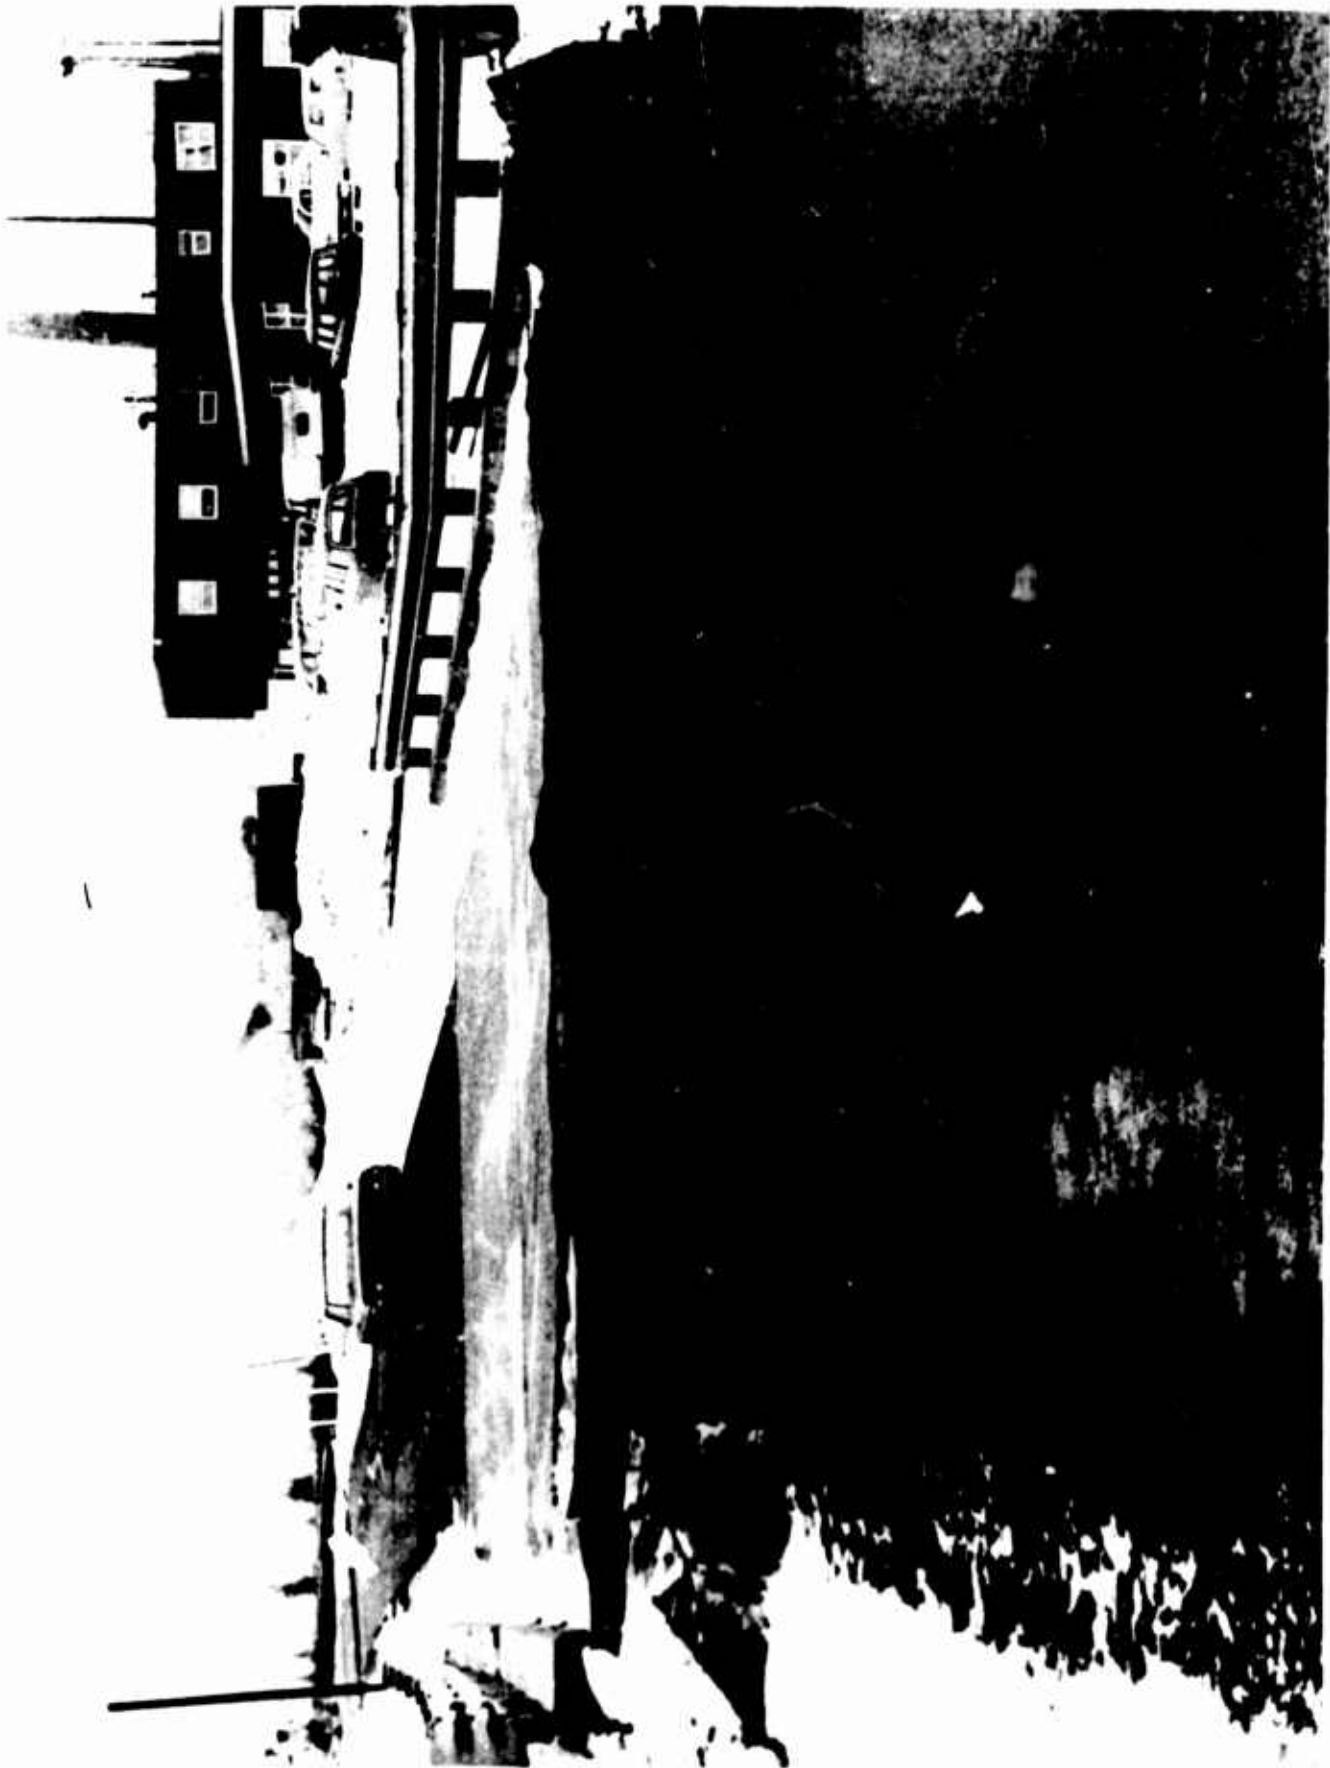
Figure 21. Roadbed Subsidence Adjacent to a Bridge, Anchorage to Seward Highway

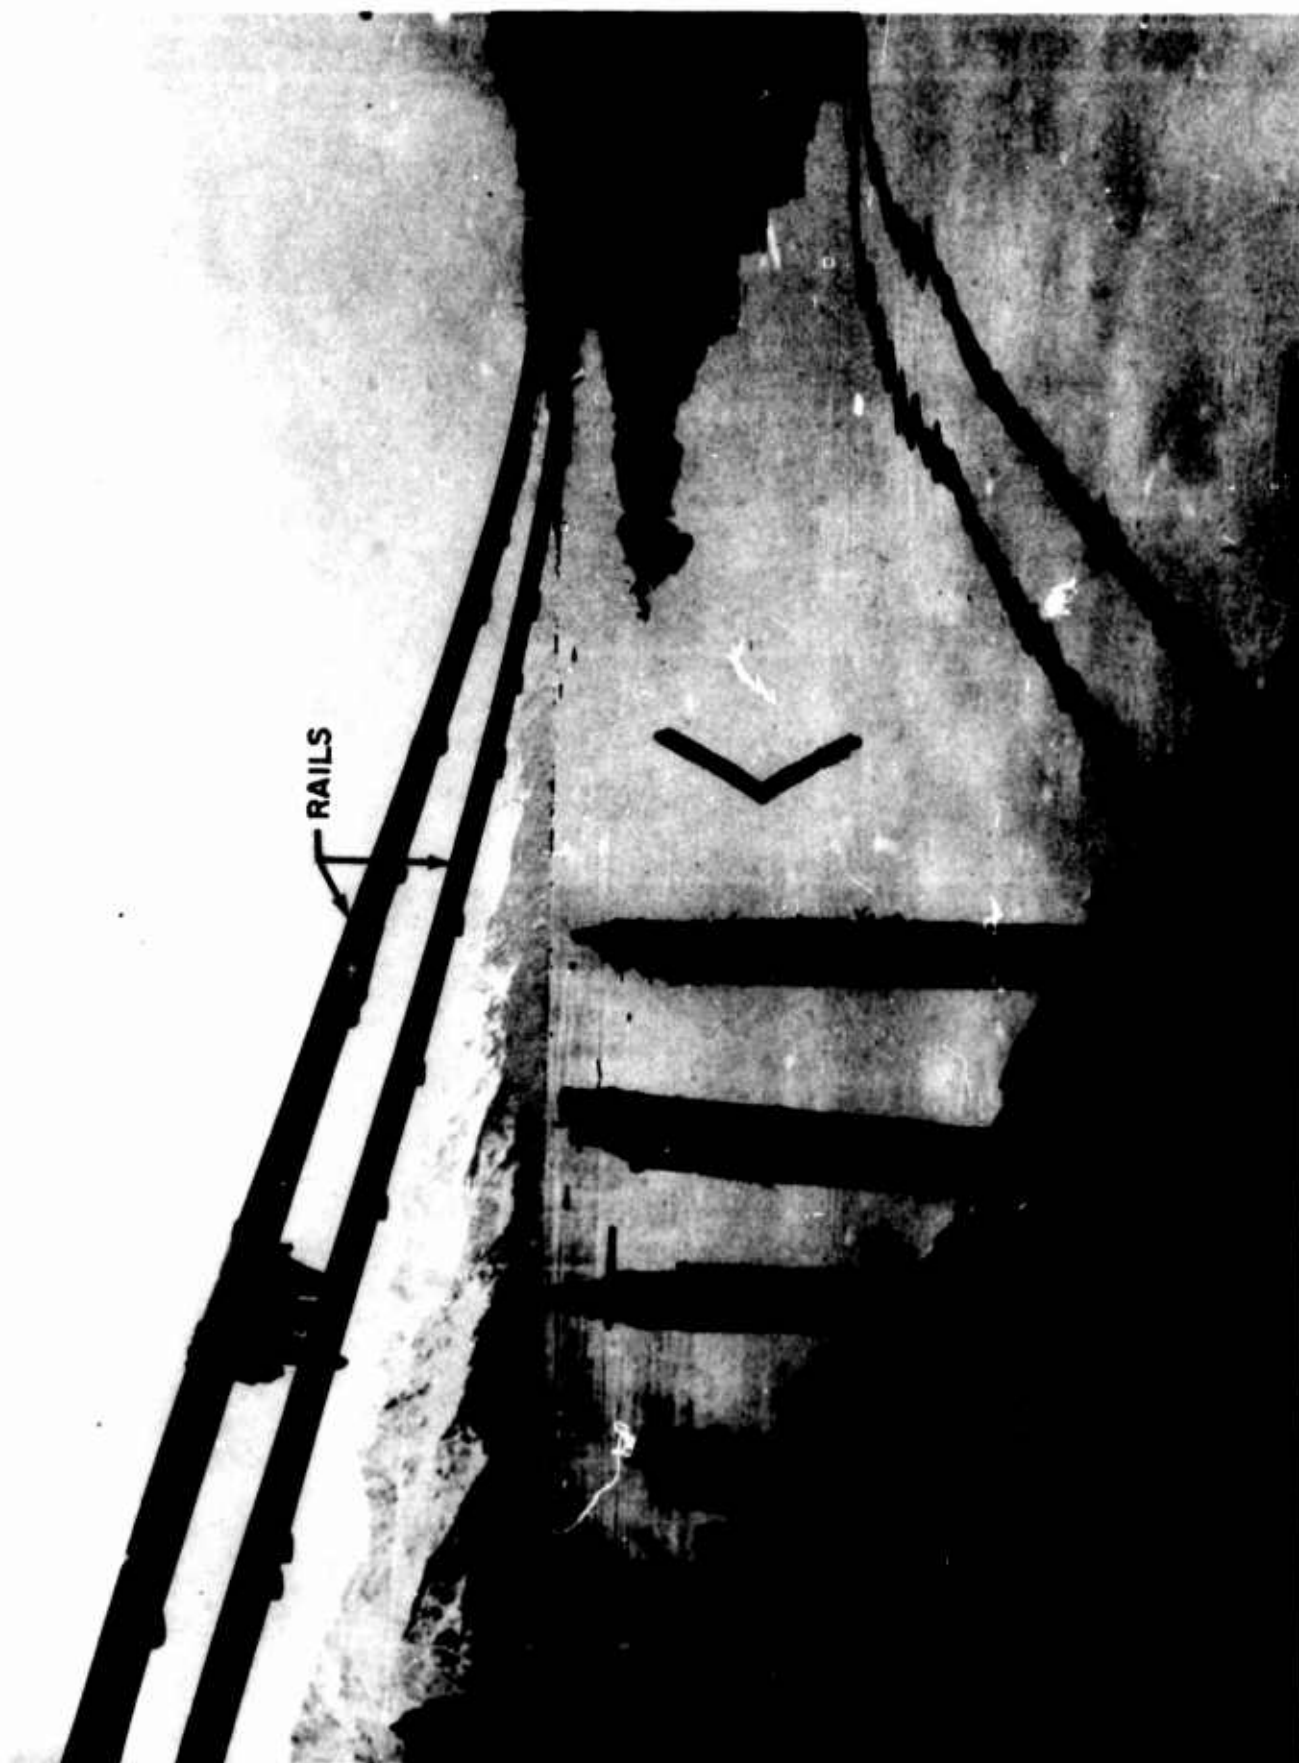
Figure 22. Railroad Bridge in Seward Destroyed by Seismic Sea Wave

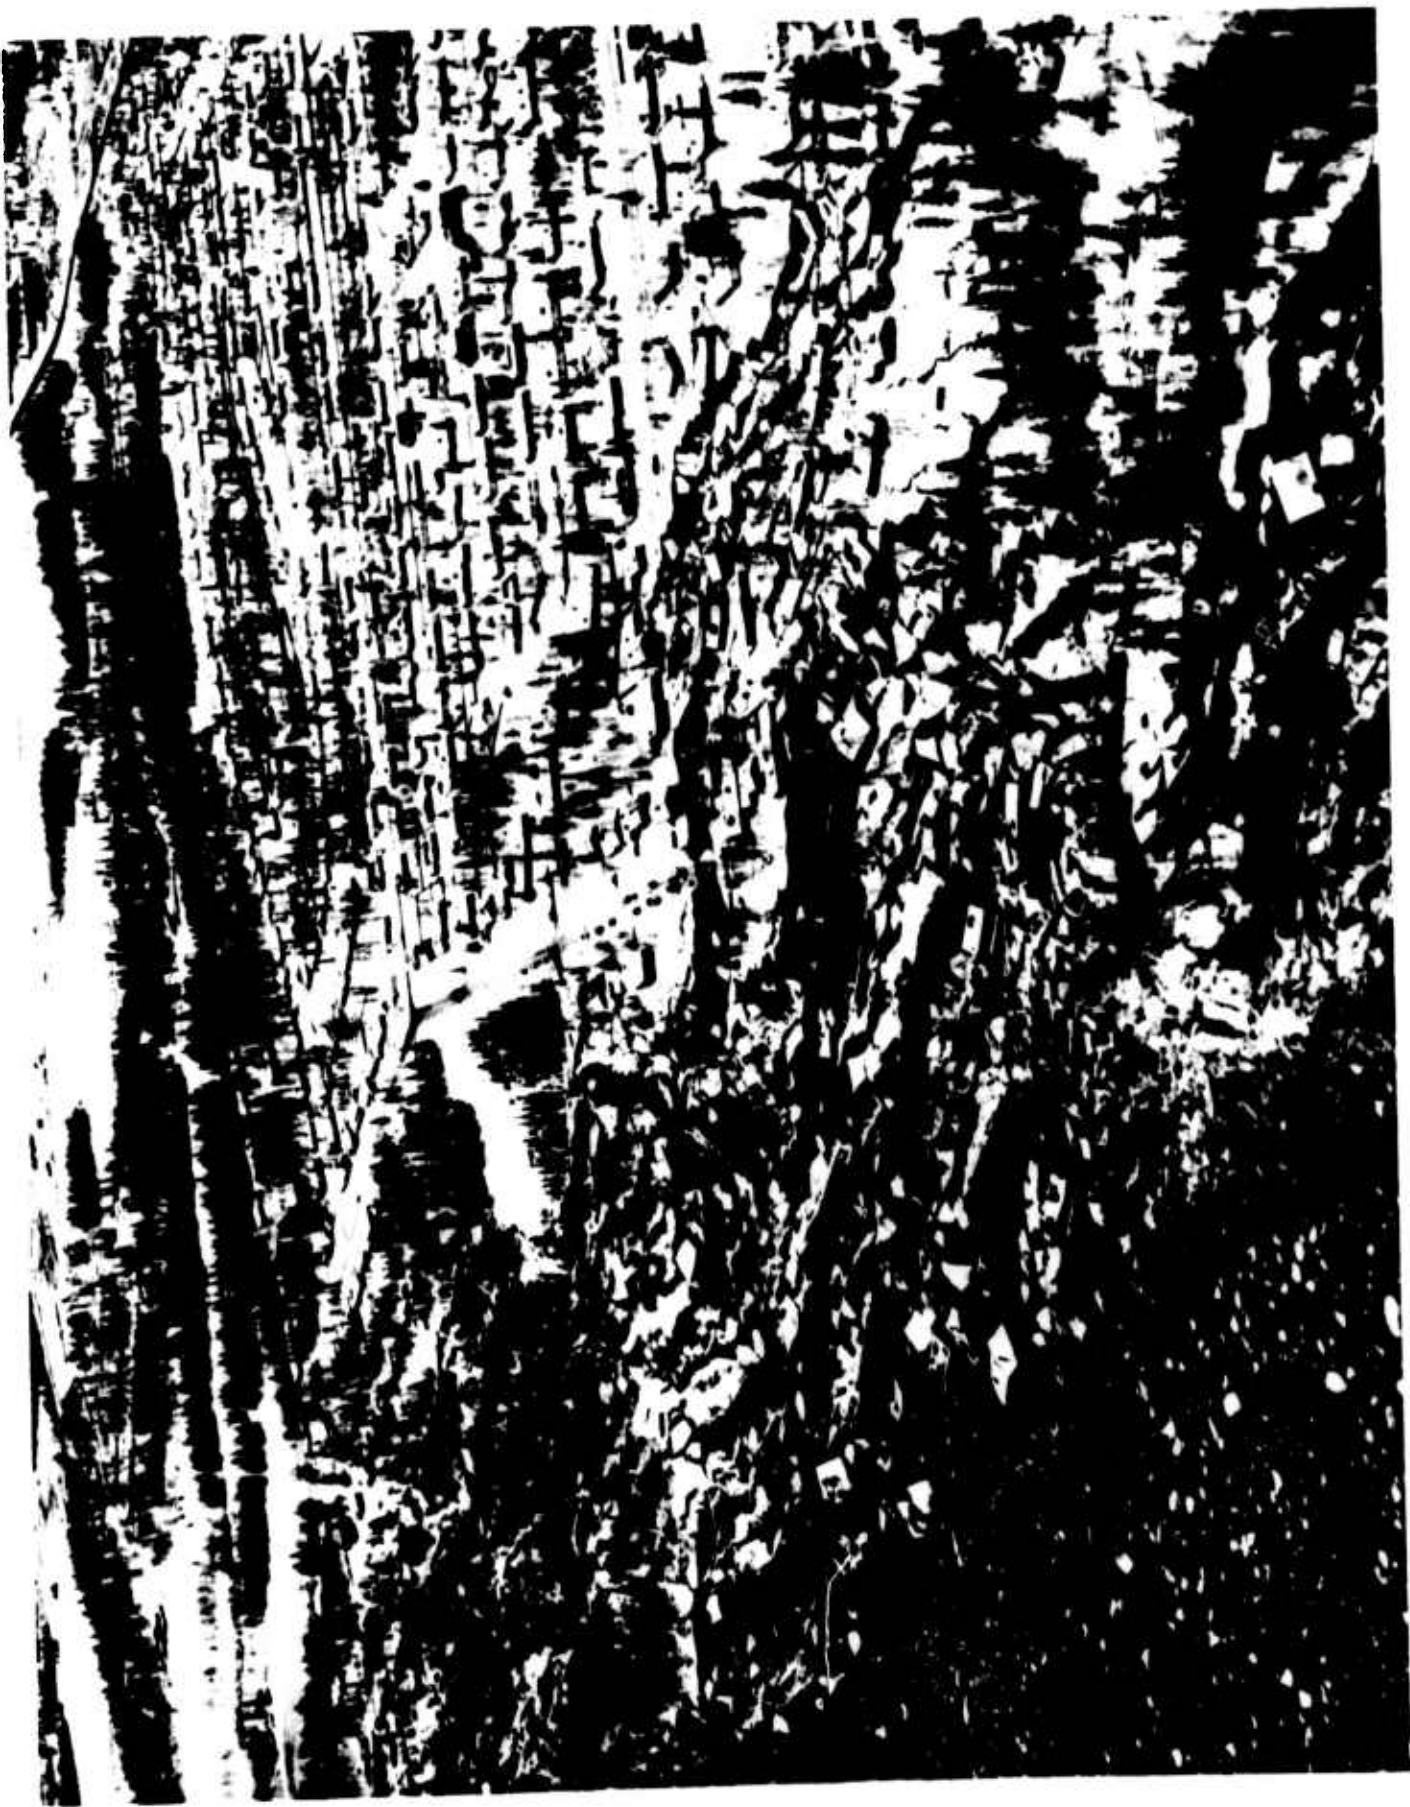
Figure 31. Turnagain Slide (Inhabited region)

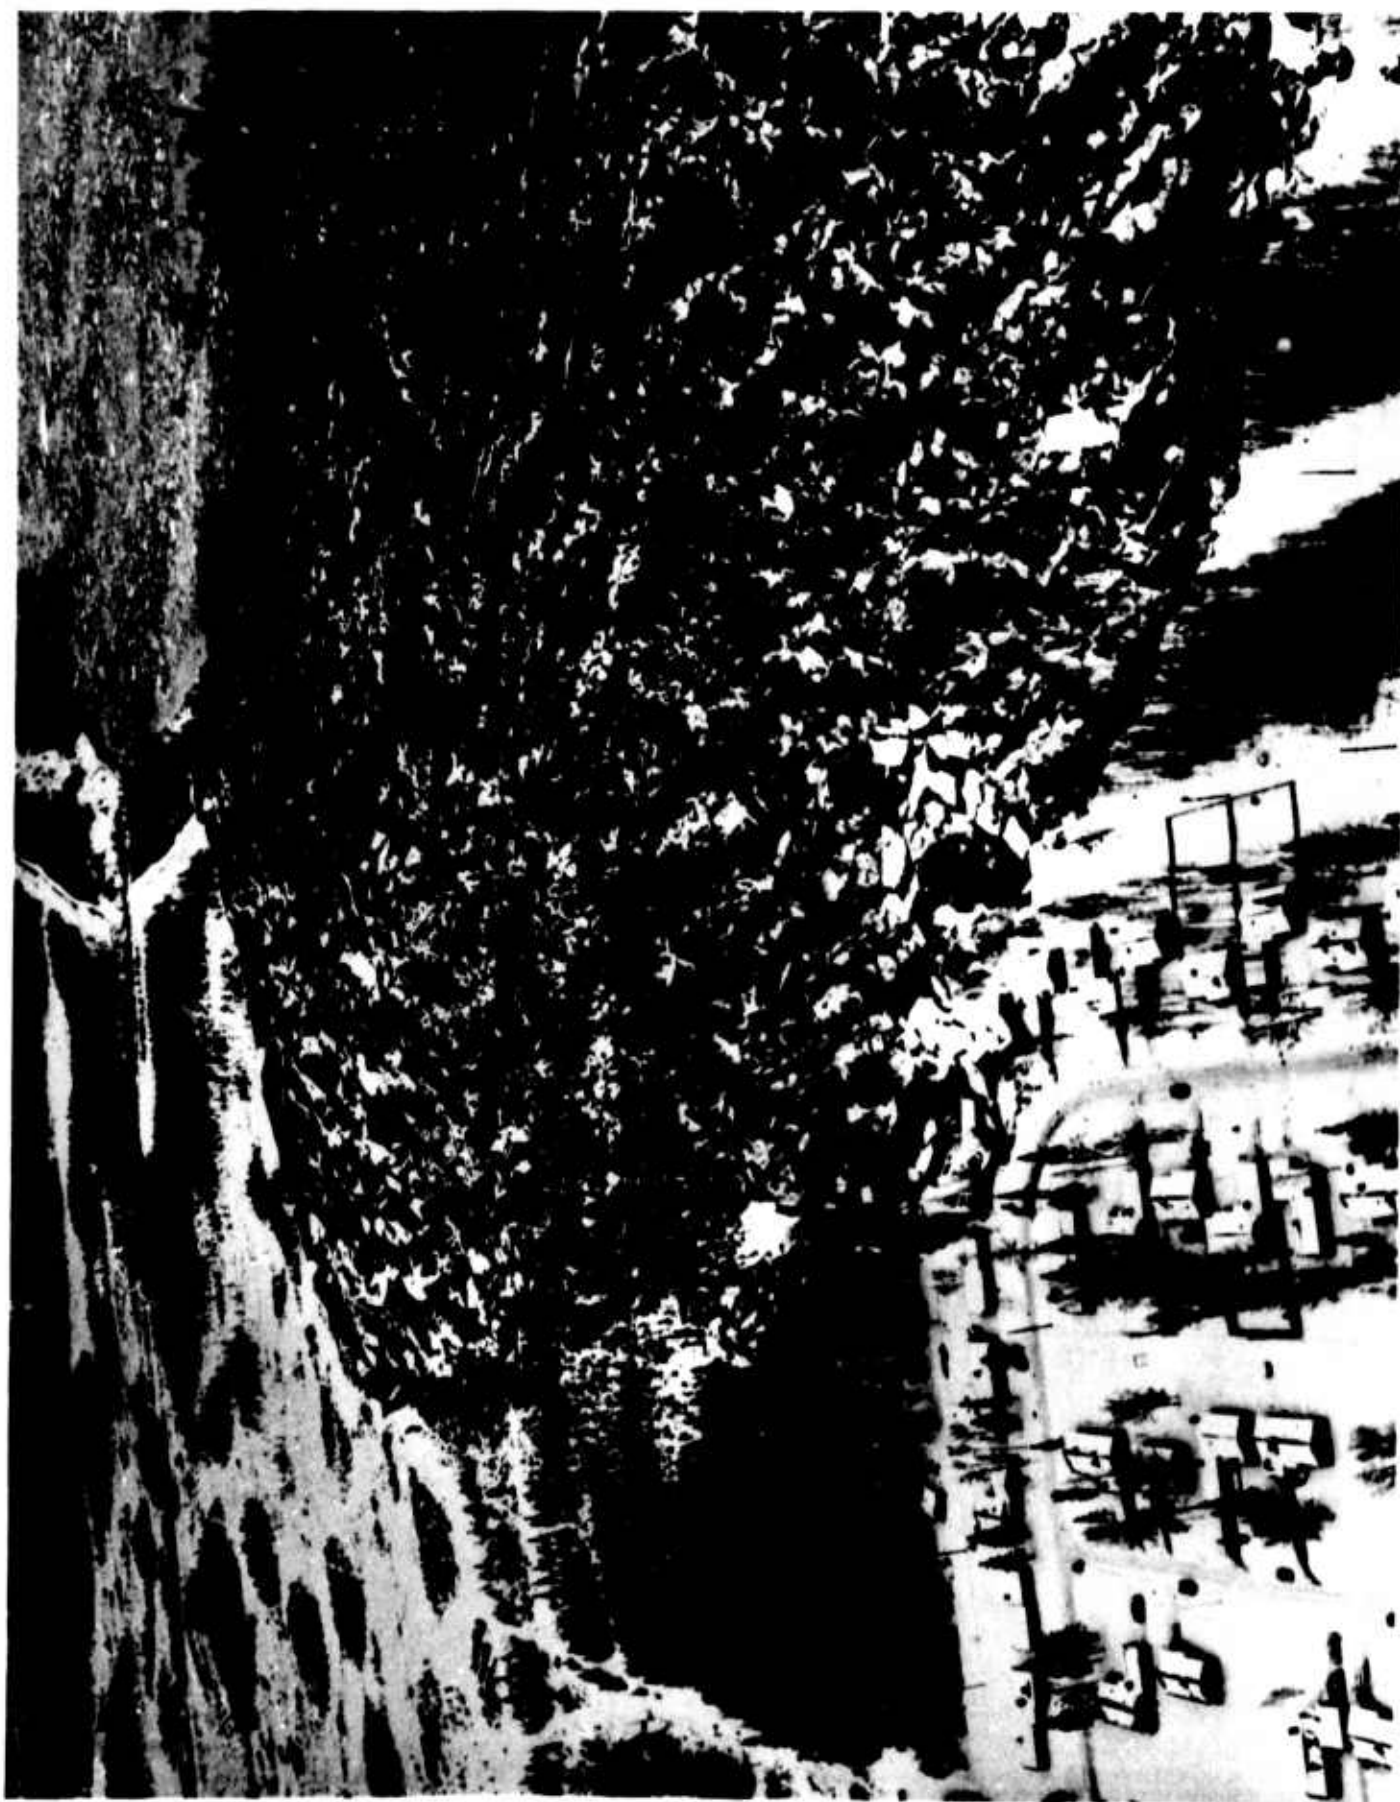
Figure 32. Turnagain Slide (Uninhabited region)

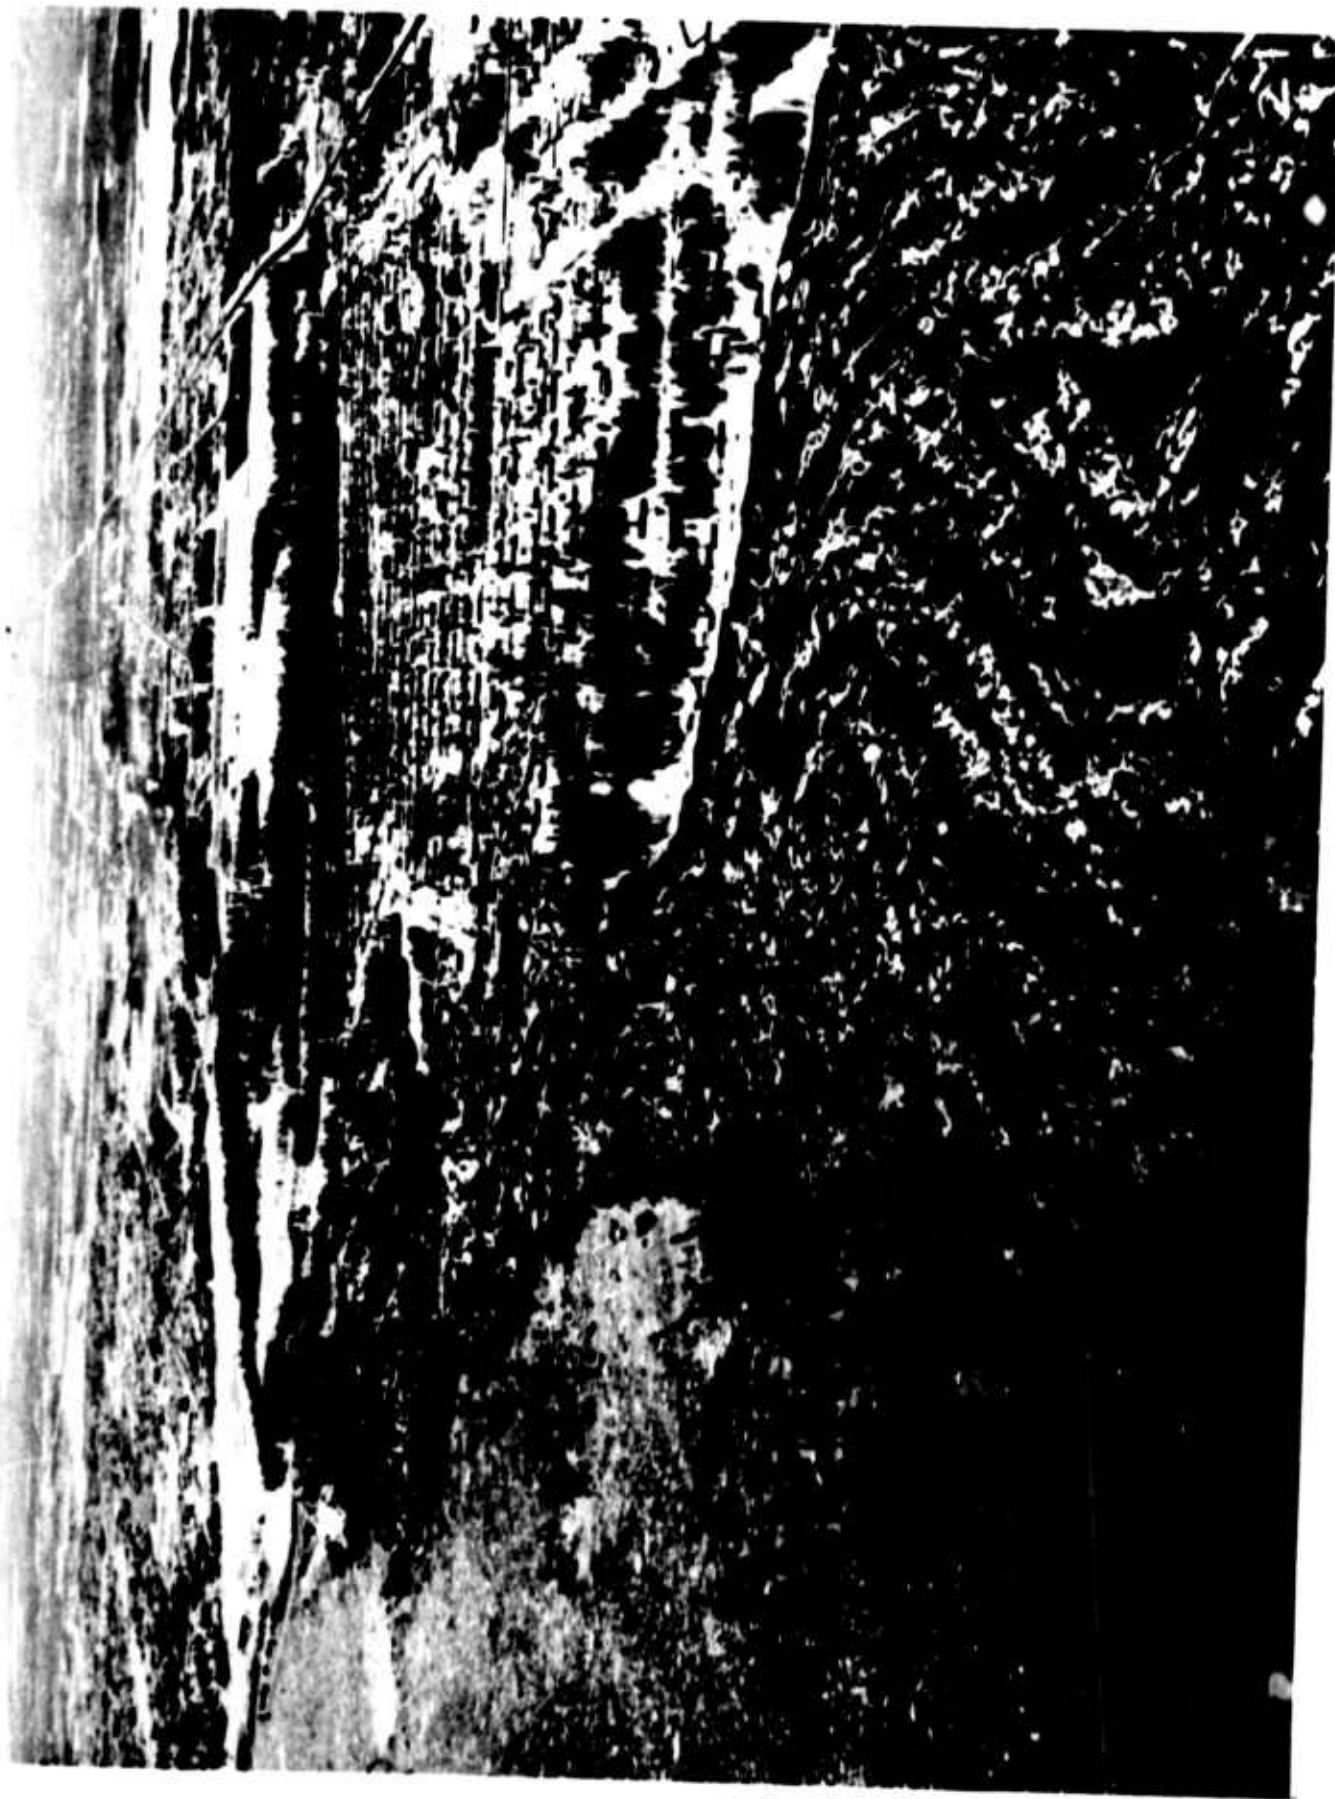
Figure 44. Turnagain Slide (Toe of the west end of the slide, eroded by tidal action)

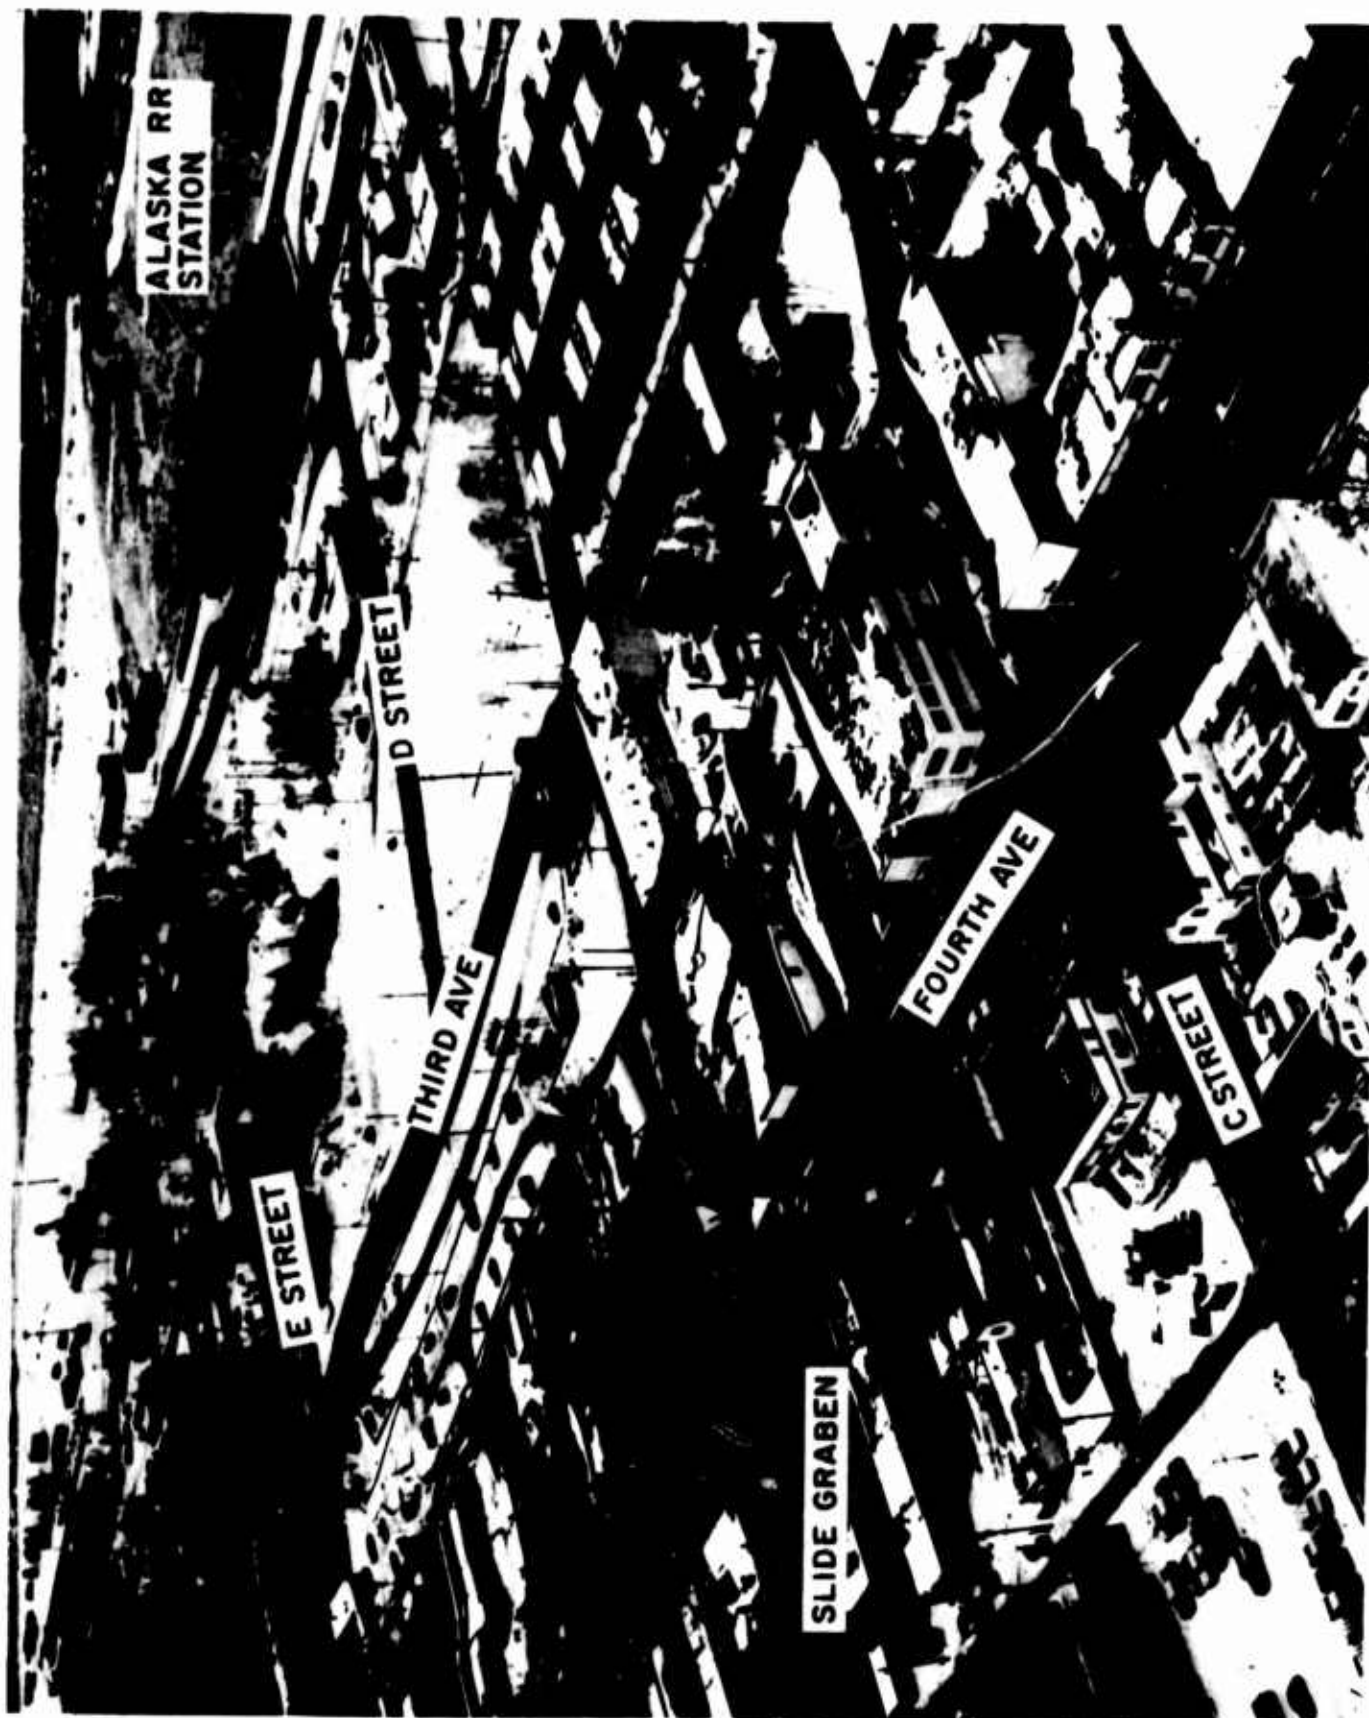
Figure 58. Fourth Avenue Slide
(Aerial view of damage to commercial buildings on the north side of Fourth Avenue)

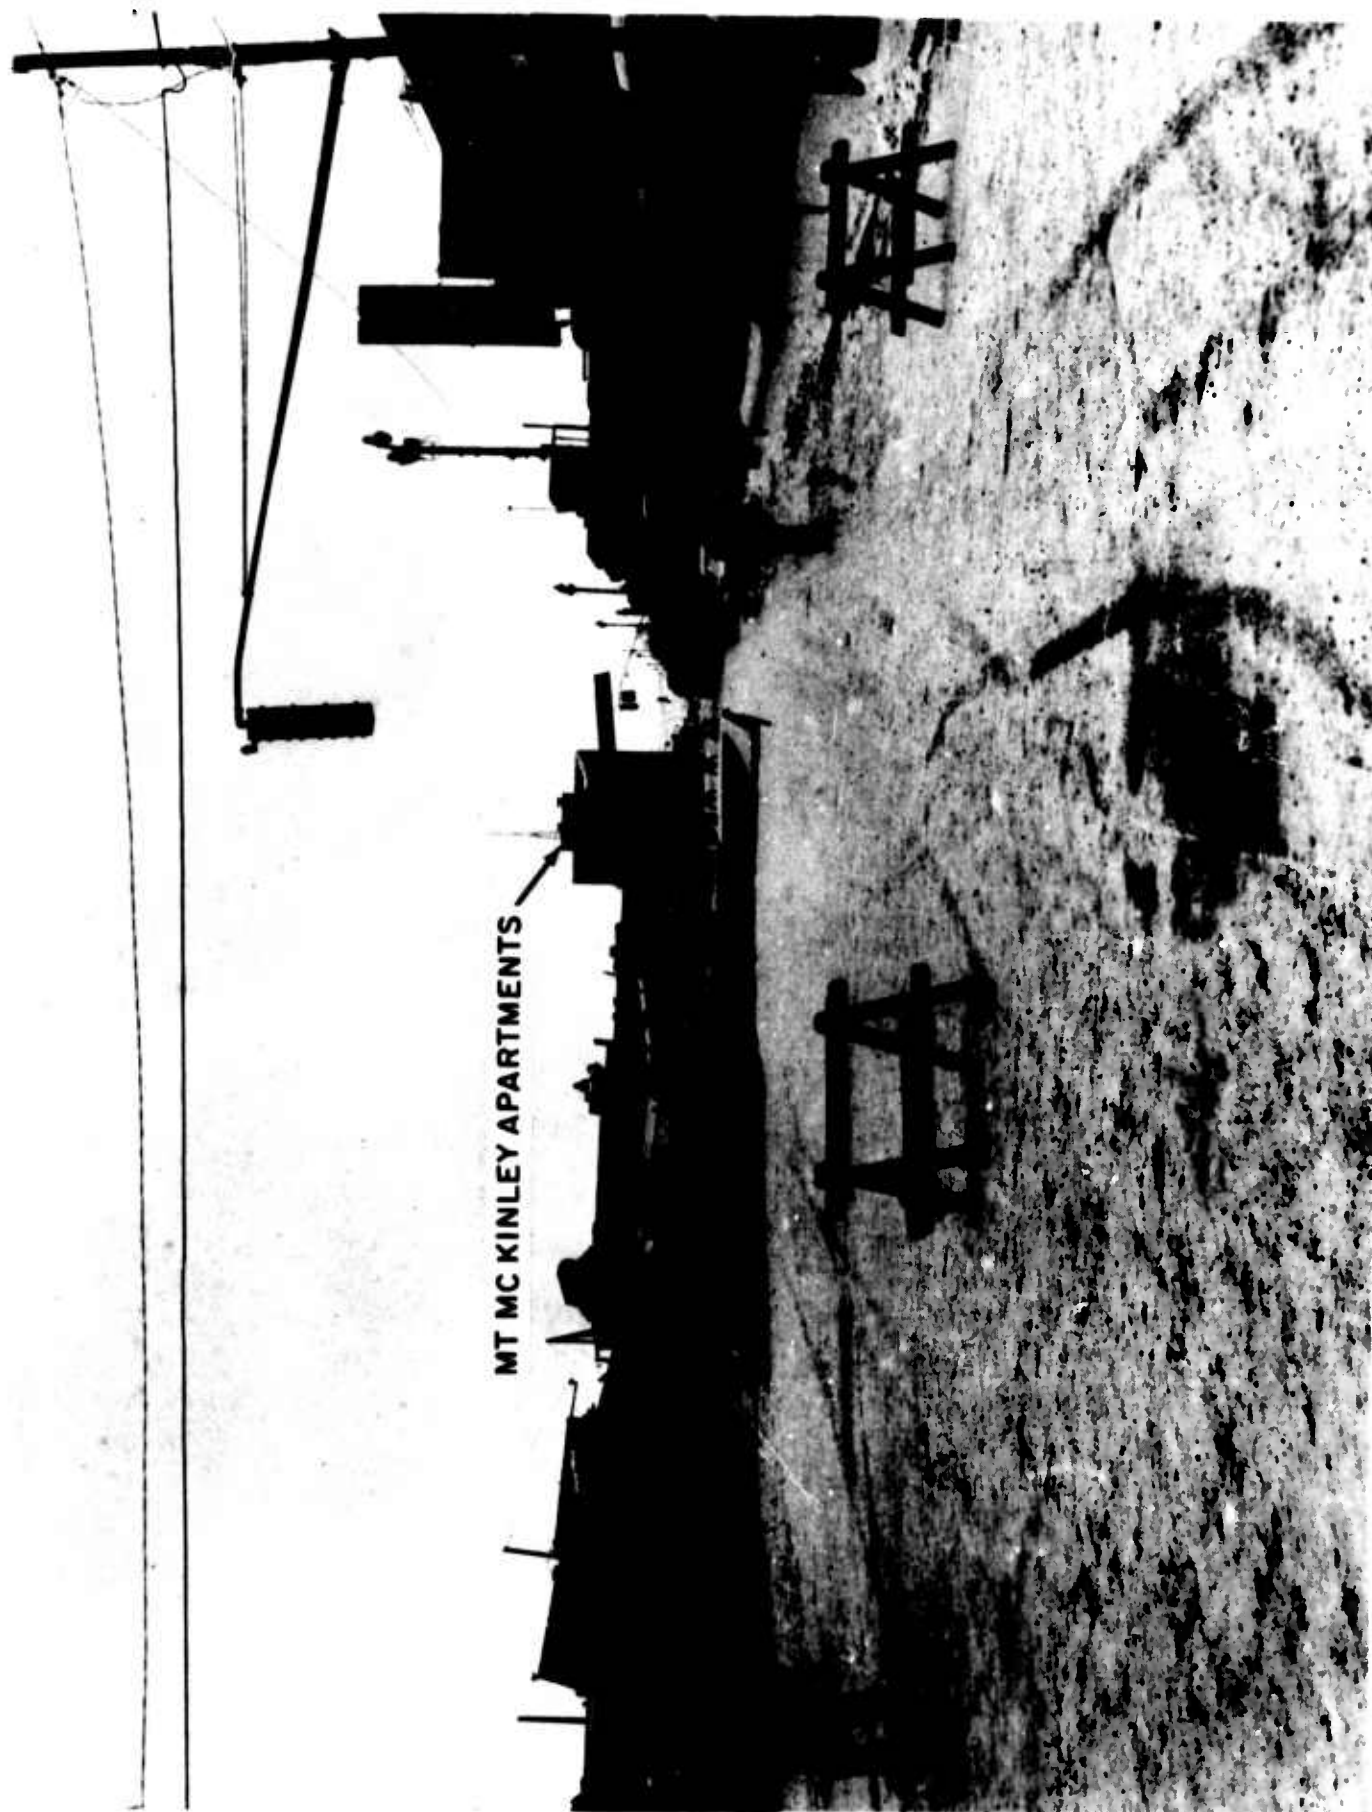
Figure 60. Fourth Avenue Slide (North side of Fourth Avenue between B and C Streets)

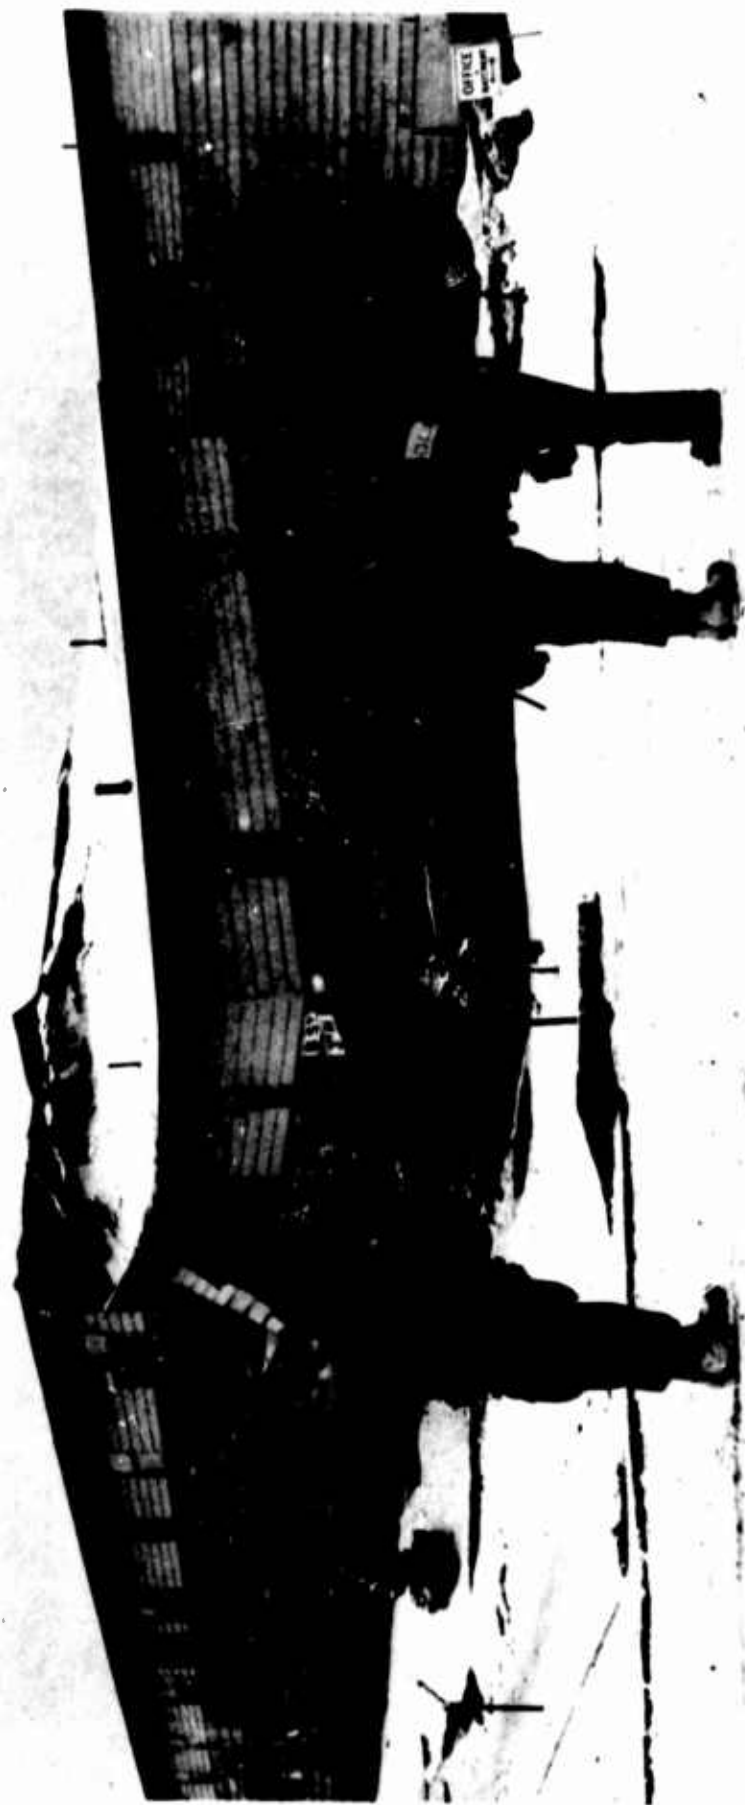
Figure 64. Fourth Avenue Slide (B Street and Fourth Avenue)
